PILIUN DE LA PAUSO

(Pilone della Posa)

RESTAURO

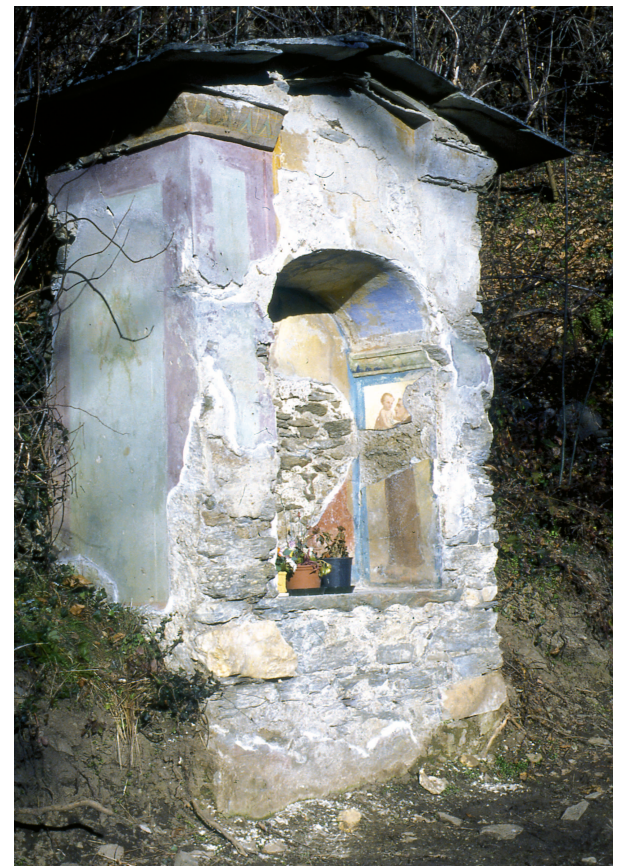
The central composition shows the death of Saint Joseph accompanied by Christ, the Madonna and an angel; and on the ceiling the dove of the Holy Spirit is depicted.

On the outside the aedicule is decorated with simple light coloured rectangles framed by a trim painted in dark colour.

In some places traces of an earlier decoration show up, a sure proof of the great age of this handmade work. The evaluation of the style and the composition of the plaster suggest a dating of the painted parts between the 1930s and 1940s. The talented painter is so far unknown.

The wayside shrine was recently restored by the municipality in connection with the project *I Bosch de l'Adrech*. It had not been used and therefore had not been maintained since the time when the new road had been built (1960); the latter crosses the old mule track that leads from the main district via the district Camposoprano to S. Bernardo delle Sottole and then to the Gilba Valley. In the course of the years the rear gap, delimited by a dry stone wall, was filled up with soil that in direct contact with the wall caused an extreme dampness almost up to the height of the stone slab covered roof. Weeds and leaks in the roof worsened the situation. Salification and frost damage completed the crumbling of the painted surface and the plaster, which was on a cement basis and therefore already little permeable.

The completed construction works consisted of digging out and removal of the material on the hill side to guarantee good air circulation, and subsequently a complete renovation of the walls. With the retrieved stones the earth retaining wall was rebuilt after draining an aquifer that had emerged at the level of the foundation. The roof was also repaired and the ground was paved with stones in *opus incertum* to facilitate the cleaning and the drainage of precipitation.

- ▶ consolidation of the plaster with deep injections of premixed hydraulic mortar
- ▶ cleaning of the painted surface with appropriate solutions
- ▶ removal of soluble salts
- ▶ recomposing of the detached and fortunately recovered fragments
- ▶ fixing of the painted film with diluted resin
- ▶ puttying of gaps in the plaster
- ▶ pictorial reintegration
- ▶ application of a consolidating and water-repellent protection
